Down-hole Camera of EPA Pavillion
Monitoring Well MW-02
Conducted on May 2, 2012
Prior to Redevelopment by the USGS

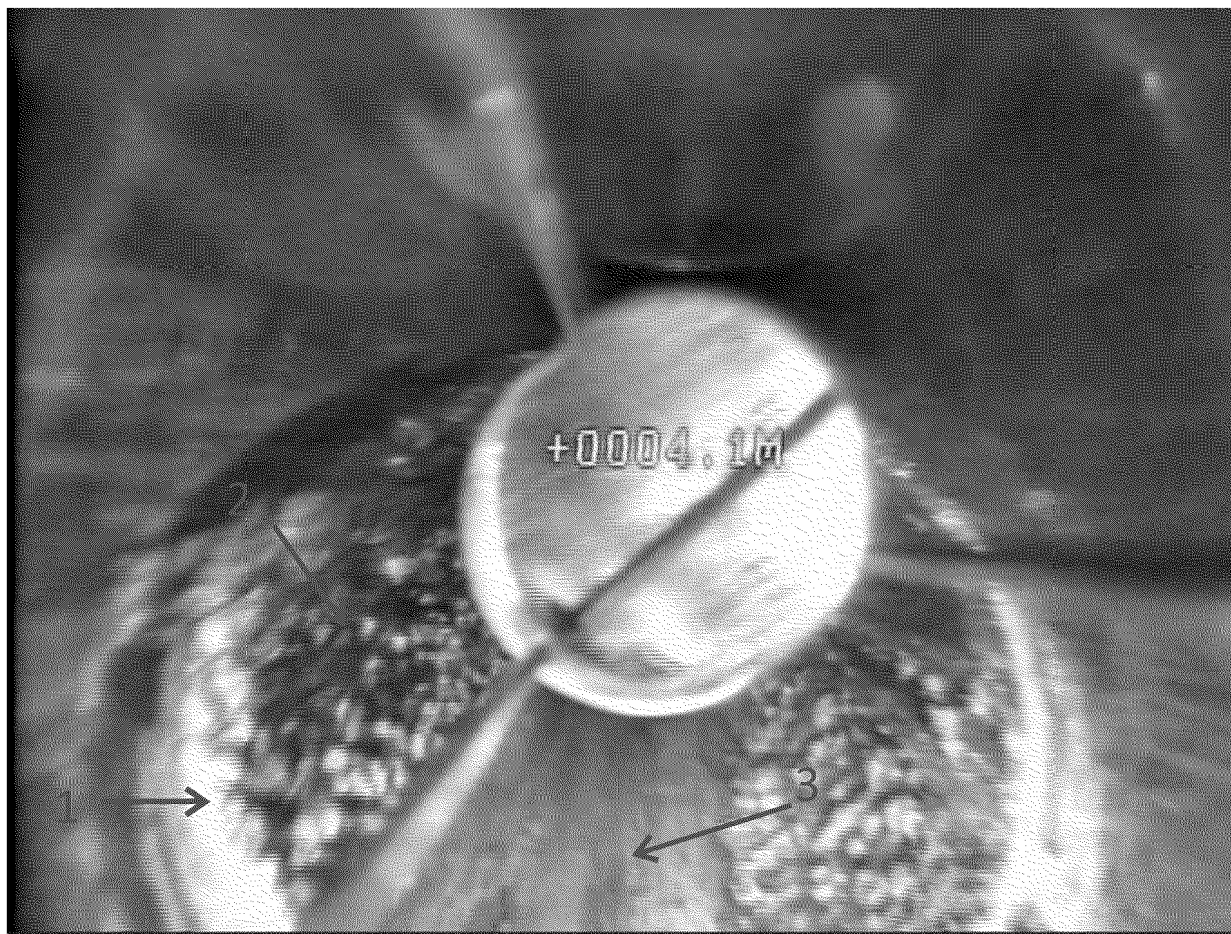
VTs_02_1.VOB at 0:07:49

Casing coupler threads exposed between pipe ends (1) and corrosion of casing below joint (2). 'Scuffed' sidewall of casing pipe (3).

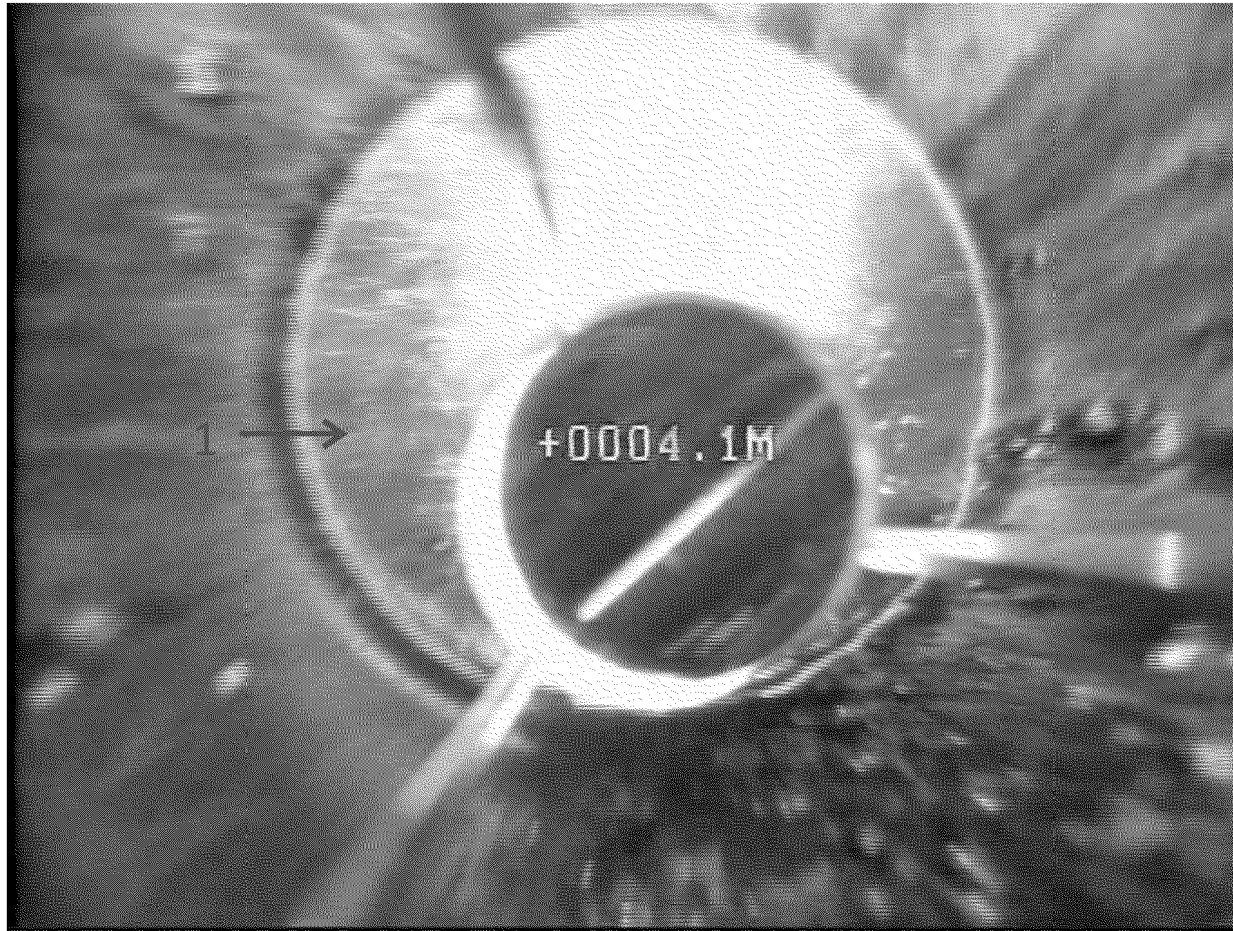
VTs_02.1.VOB at 0:07:54

Water surface (1) encountered at approximately 173-ft below top of casing (btoc).

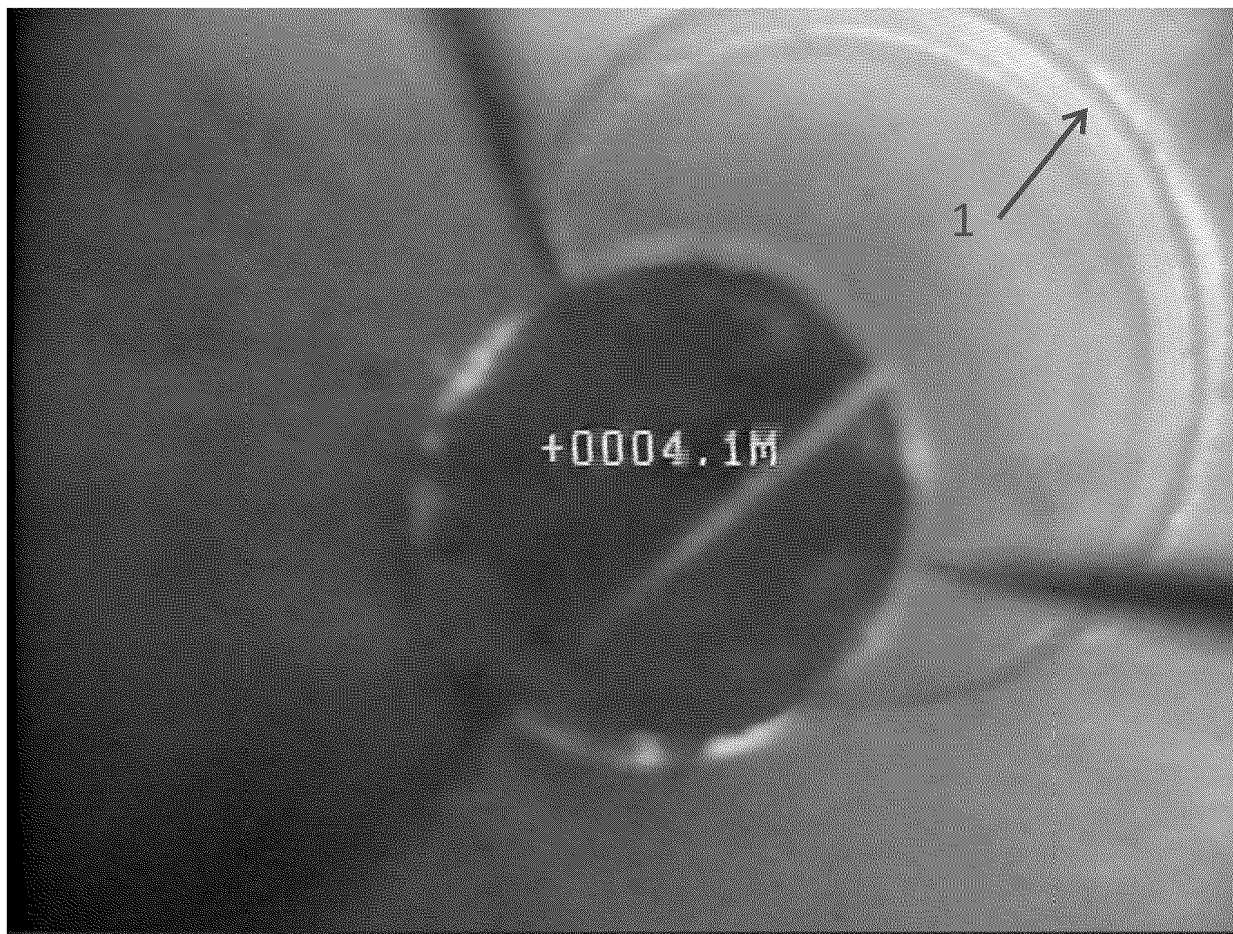
VST_02_4.VOB at 0:06:43

Threaded joint (1) prior to screened interval.

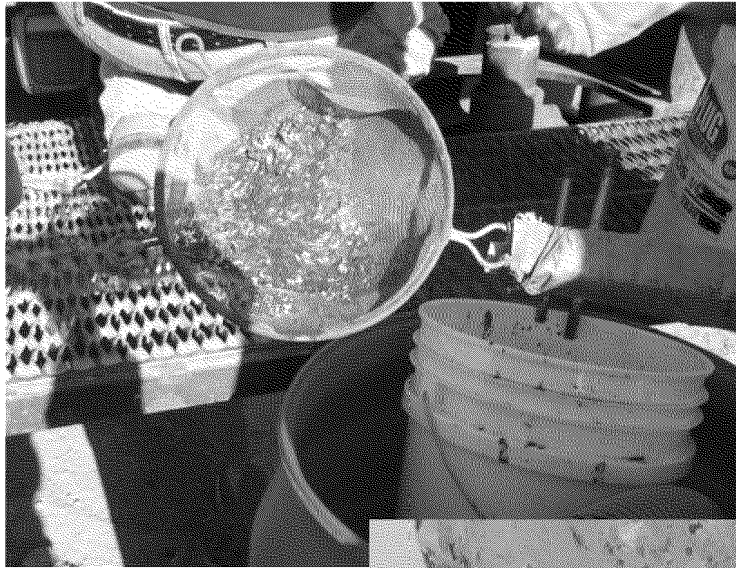
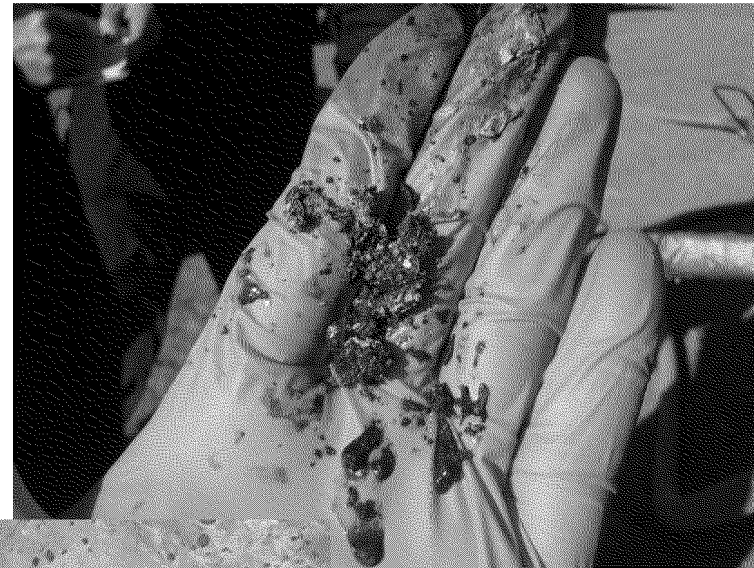
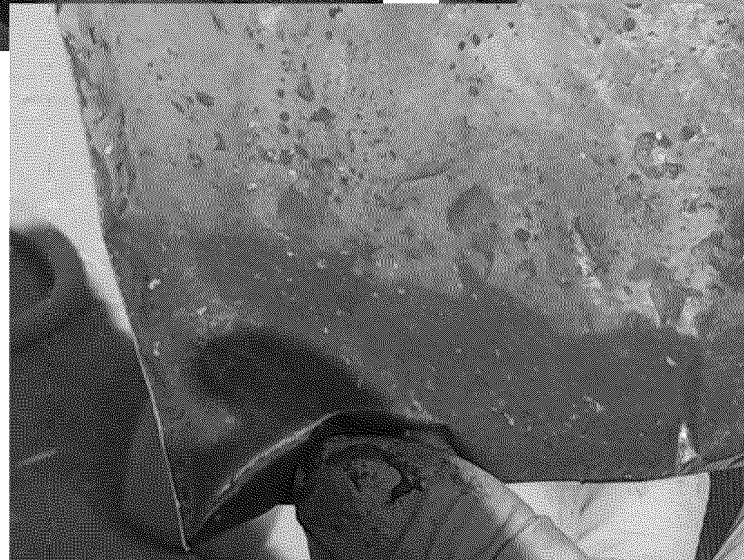
Material removed from MW02 during redevelopment of well by USGS, May 2012
